## Pilbara Rail Repair Team ~ Page 1

18230005 Custom WERKS® Brake Component Storage Box

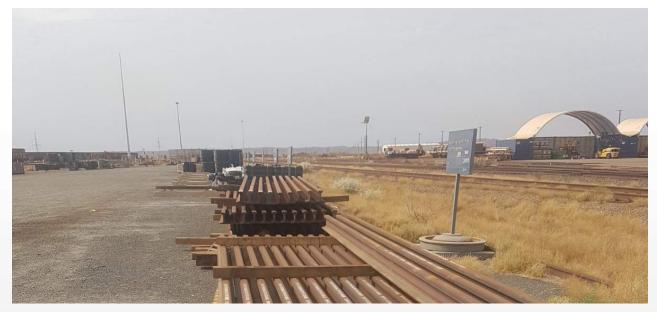
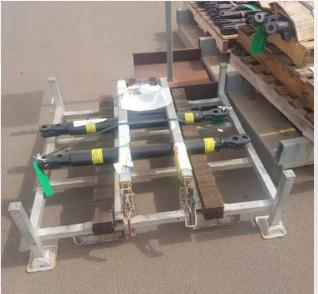
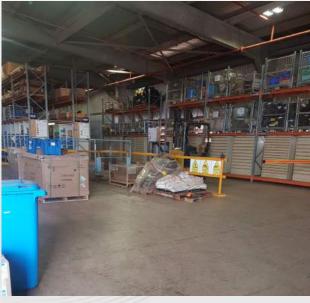
Previously, the parts and components were transported in or on whatever was available - pallets, stillages, crates etc. This was inefficient and the lack of clear labelling made it difficult to keep track of the items.

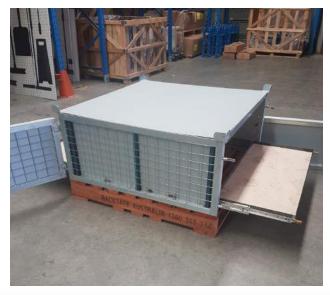
We started out with a simple design based on the WERKS® 325mmH Bolt On Pallet Cage. Modifications included cladding the outside of the cage and installing two pull-out platforms, accessed from front and rear via the swinging gates.

After testing this out with the client, and the concept being approved, a test run of ten storage boxes was rolled out in December 2018. These had full steel frames, drawers at front and rear, latch lockable doors at front and rear, provision for stacking and forklift/pallet jack pockets.

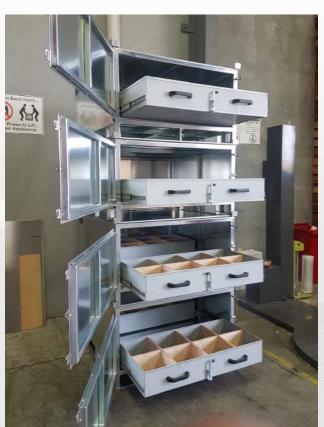
Come May 2019, we were proceeding with the next stage of this project. With trials on site completed, we were armed with feedback and constructive criticism to fuel us on our quest for the best. We fabricated another 13 trial units based on the feedback we had received - safety is always a key priority for a new design, and here are the safety concerns we addressed:

- 1. Sharp edges 'safe rolled edges' created on the drawers
- 2. Visibility hazard when doors open hinges fitted to doors allow 270° opening, doors sit flat against side of box when open
- 3. Inefficient drawer locking single centre-bolt mechanism allows easy operation by one person; two pull handles reduces strain risk
- 4. Doors didn't seal closed doors now sit flat against frame, keeping moisture and dust out
- 5. Damage to contents and divider system use timber for a malleable, yet strong, divider system that is easy to swap out
- 6. Theft, misplacement and misuse identification plates fitted to each storage box with load rating details

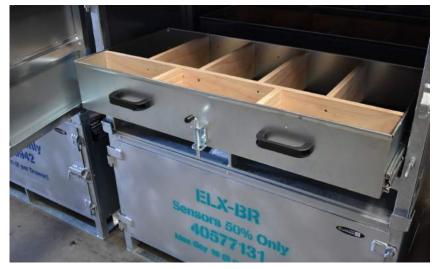
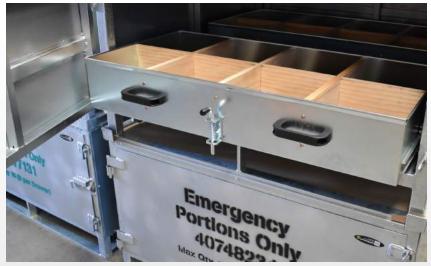
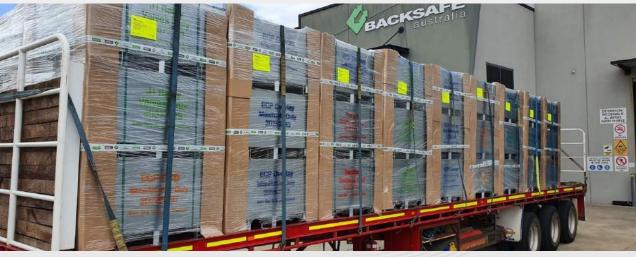
Despatch of 54 units to the Pilbara in February 2020, with custom identification and load guide stencilling to fit the purpose/usage field of each storage box.
